CALIFORNIA GULCH LAKE COUNTY, COLORADO SUPERFUND CASE STUDY

A Once Toxic “Moonscape” from Mining and Smelting Is Returned to Fertile Pasture and Native Prairie

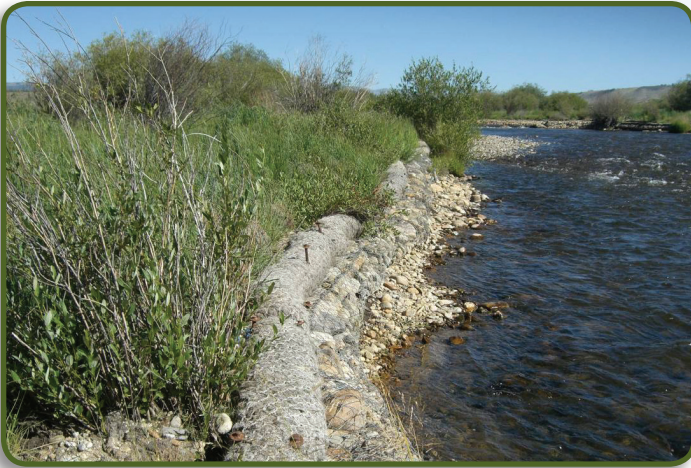
Streambank after treatment

- Excavation of contaminated soil within 10 feet of the streambank and replacement with clean fill
- Rock roll along the toe of the stream bank
- Coir roll (biolog) along the toe of the stream bank or behind the rock roll
- Sedge (*Carex* spp.) plantings
- Mature willow (*Salix* spp.) transplants
- Tipped willows that extend into the river

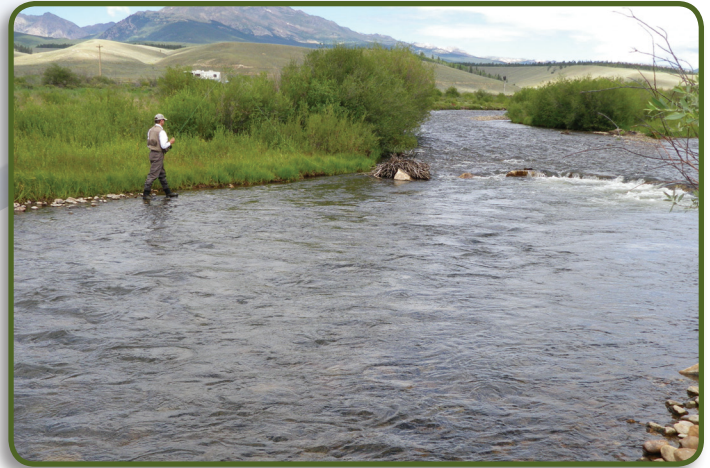
Fishing along the revitalized streambank

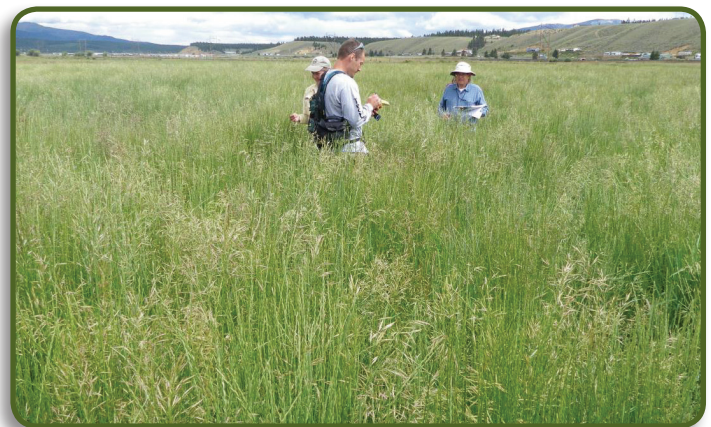
Smith Ranch vegetation assessment, 2010

- **Soil criteria** include post-treatment soil characteristics such as pH, lime requirement, organic carbon, and electrical conductivity.
- **Vegetation criteria** include seedling density (first-year measure only), cover, species richness, biomass, and evidence of reproduction.
- **Irrigated meadows criteria** were developed from the results of pre-remediation sampling in contaminated and uncontaminated meadows
- **Fluvial deposits criteria** were based on the characteristics of the demonstration areas
