Soil Treatment at the California Gulch NPL Site for Vegetation Reestablishment and Mitigation of Metal Mobility

Stuart Jennings, RRG, Jan Christner, URS
Mike Holmes, EPA and John DeAngelis, PWT

Operable Unit 11 of the California Gulch Superfund Site near Leadville, CO

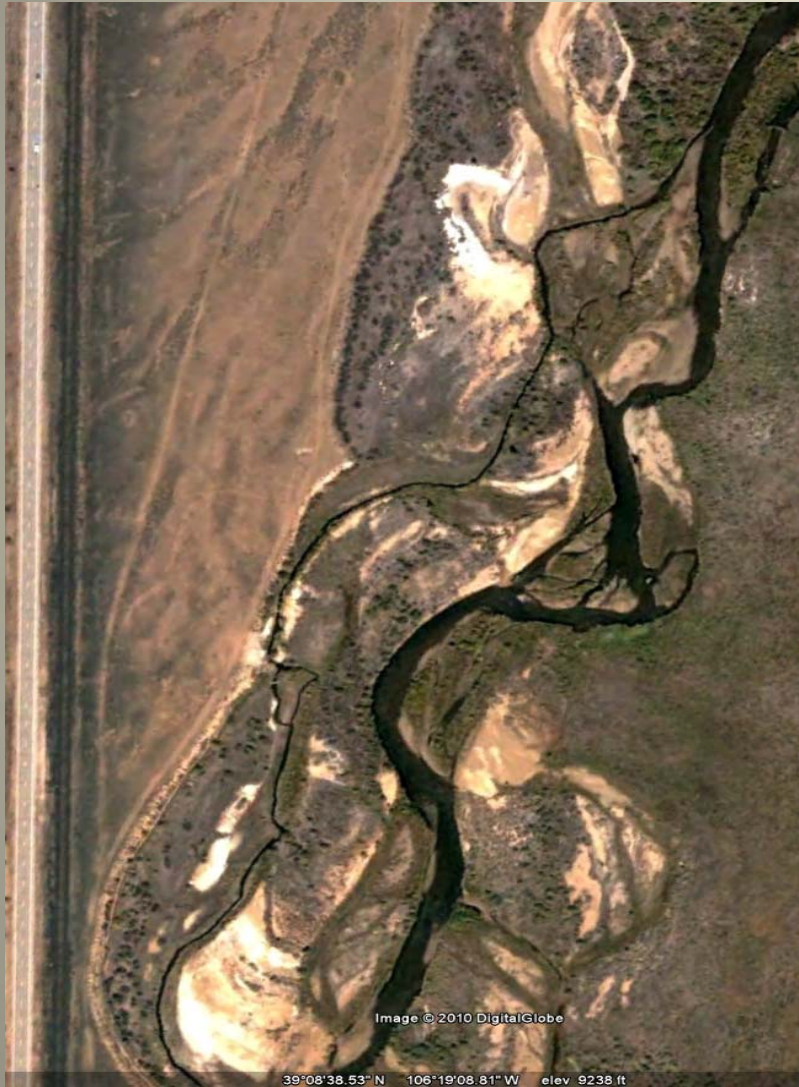
Pre-Treatment (~2008)

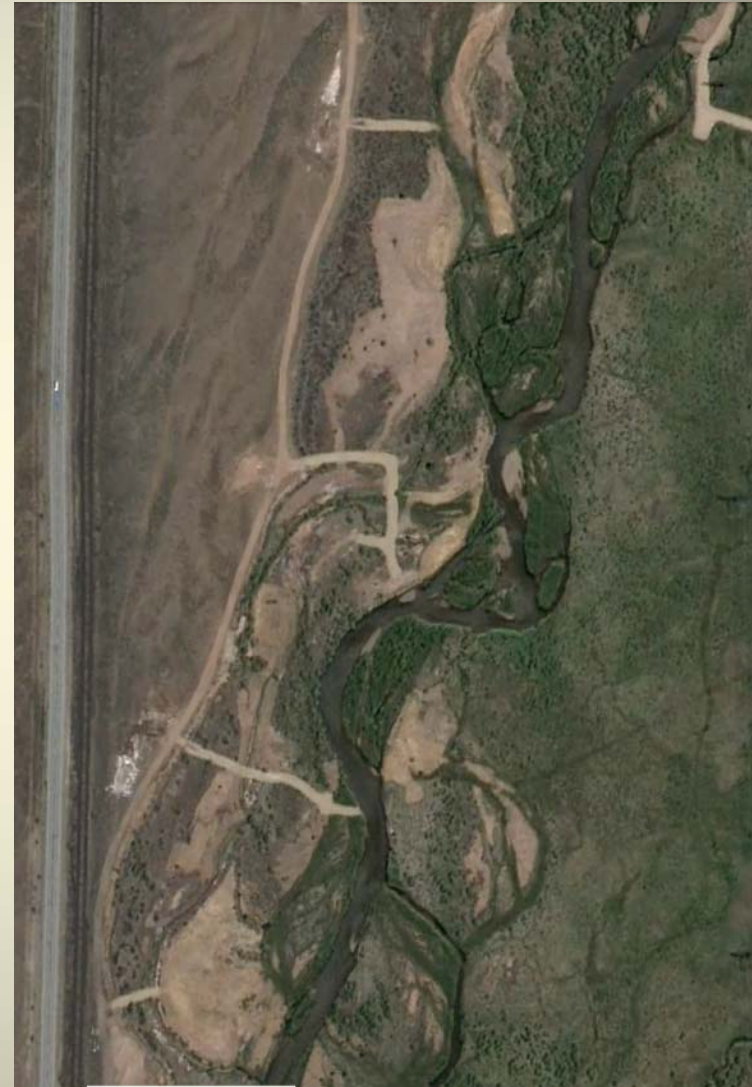
Post Treatment (~2010)

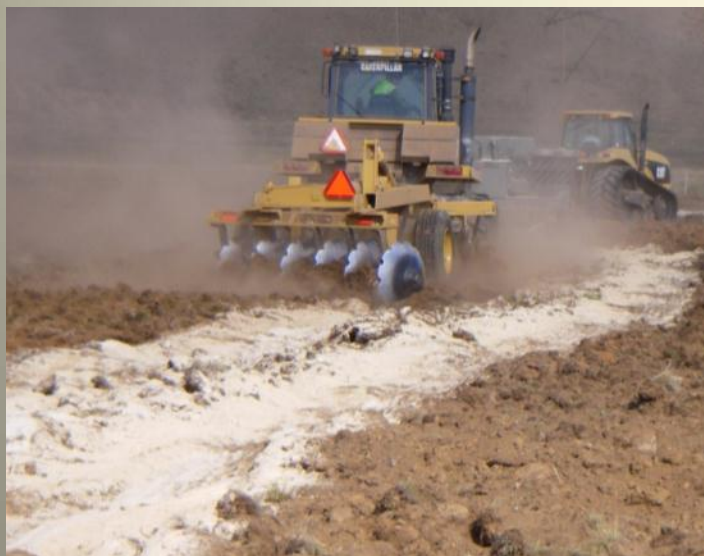
Irrigated Meadow Contamination

- 153 acres treated to either 6 or 12 inch depth using a tractor-pulled plow
- Thin deposits of relatively uniform depth

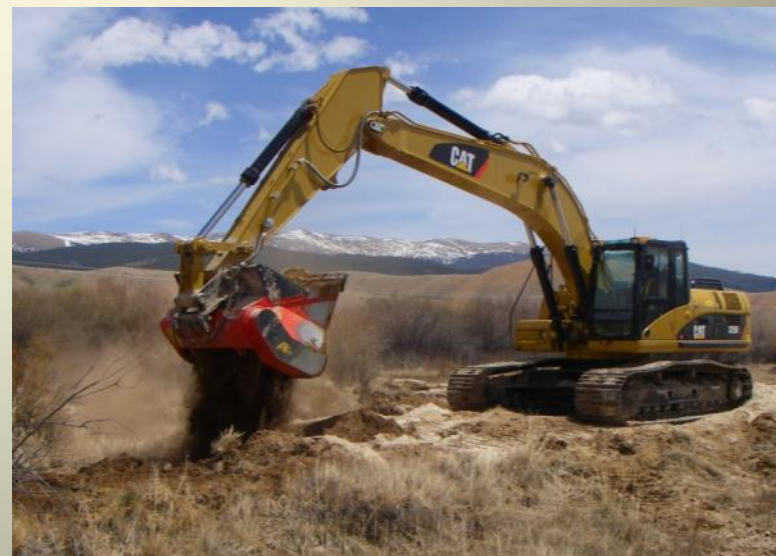
Fluvial Tailing Deposits

- 18 acres treated with an excavator-mounted soil mixer
- Thick deposits of varying depths within the floodplain

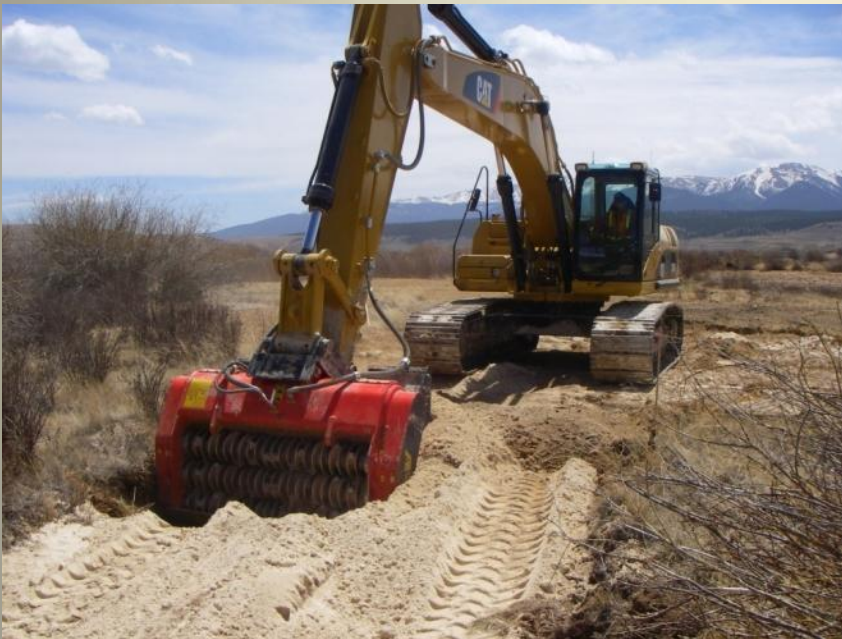
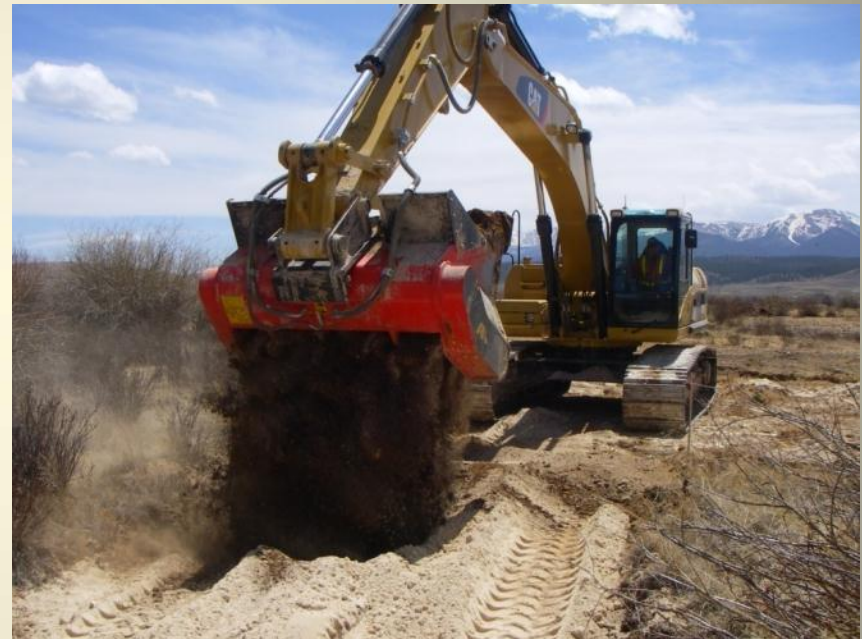
Lime Amendment Mixing into Fluvial Tailing Deposits

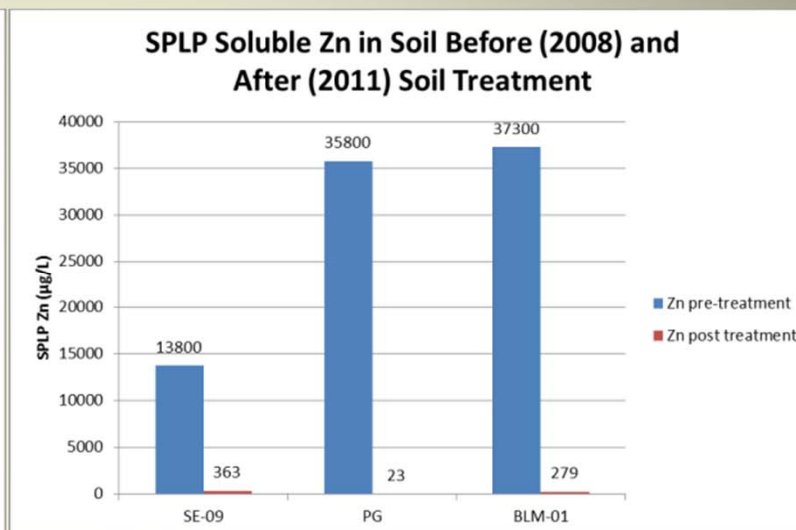
Changes in SPLP Soluble Metal Levels Before and After Treatment

Post-Treatment Comparisons between Totals and Water Soluble levels	Pb	Zn
Water soluble as a percent of total	0.022%	0.065%
Total as a factor of soluble	4588X	1543X

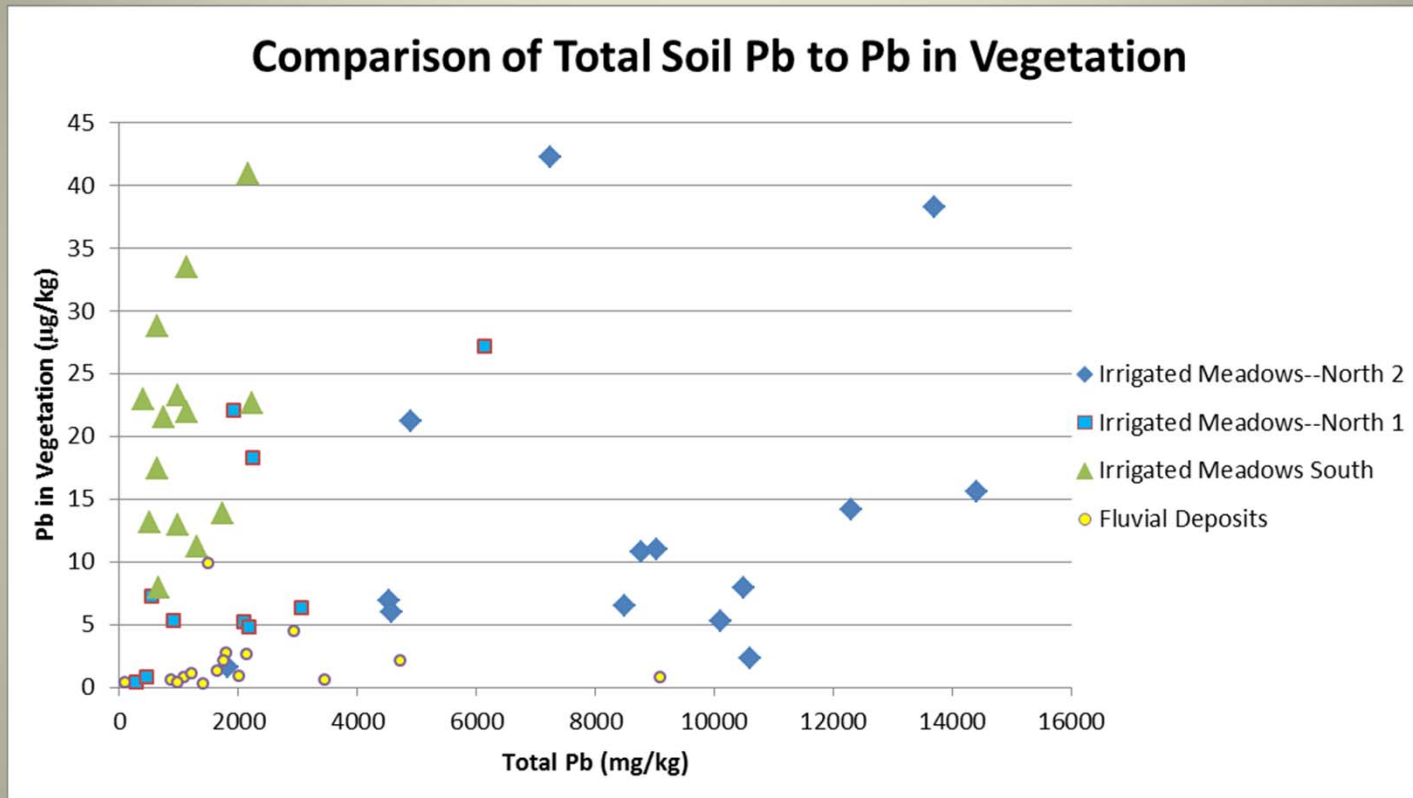
Lead levels in Vegetation

The amount of Pb in vegetation appears unrelated to total Pb in soil. Differences are apparent by site.

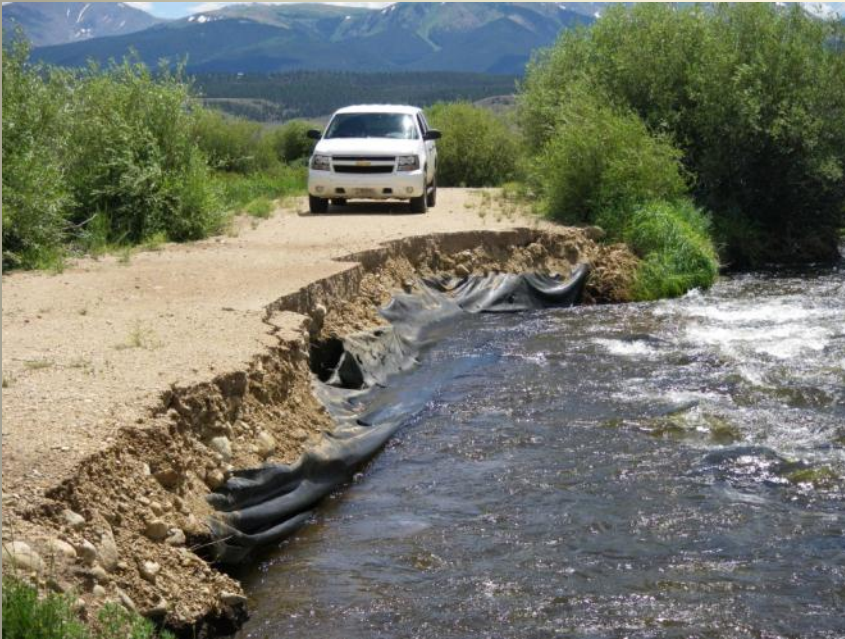
Streambank Repairs due to High Flow in 2011

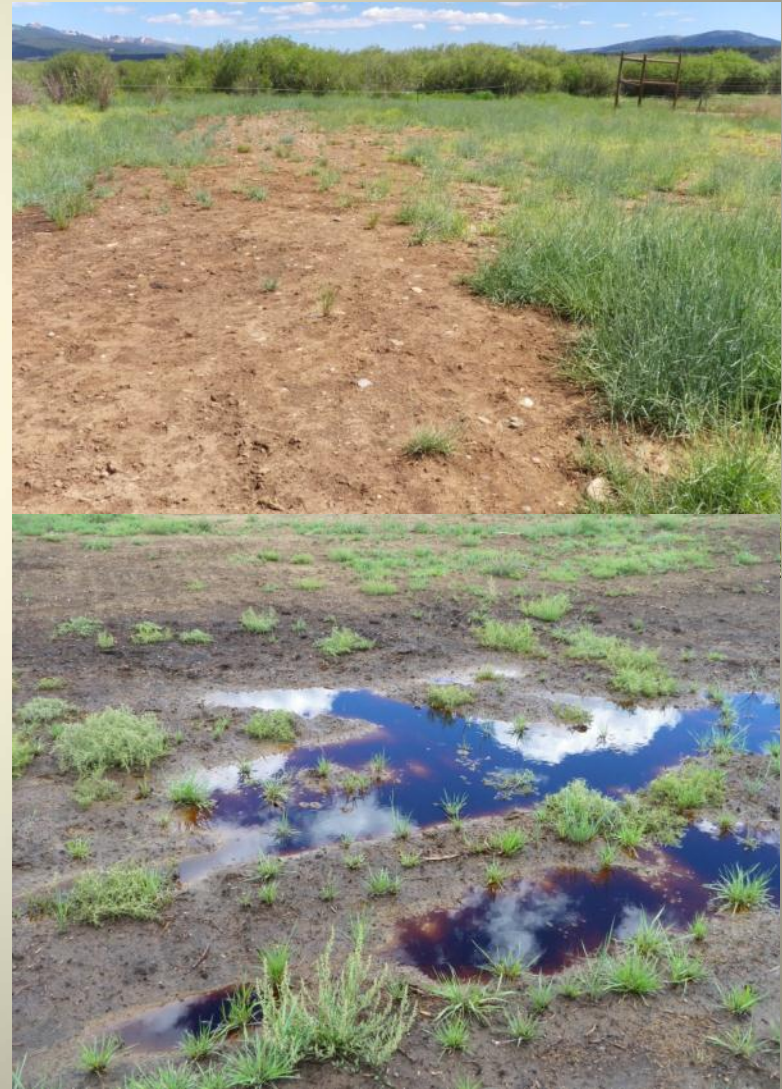
Reseeding Bare Spots caused by Excess Salinity
