2016 International Petroleum Environmental Conference

MINE TAILINGS DRAINAGE – A BOTTOMS UP APPROACH USING HDD DRILLING AND INSTALLATION METHODS

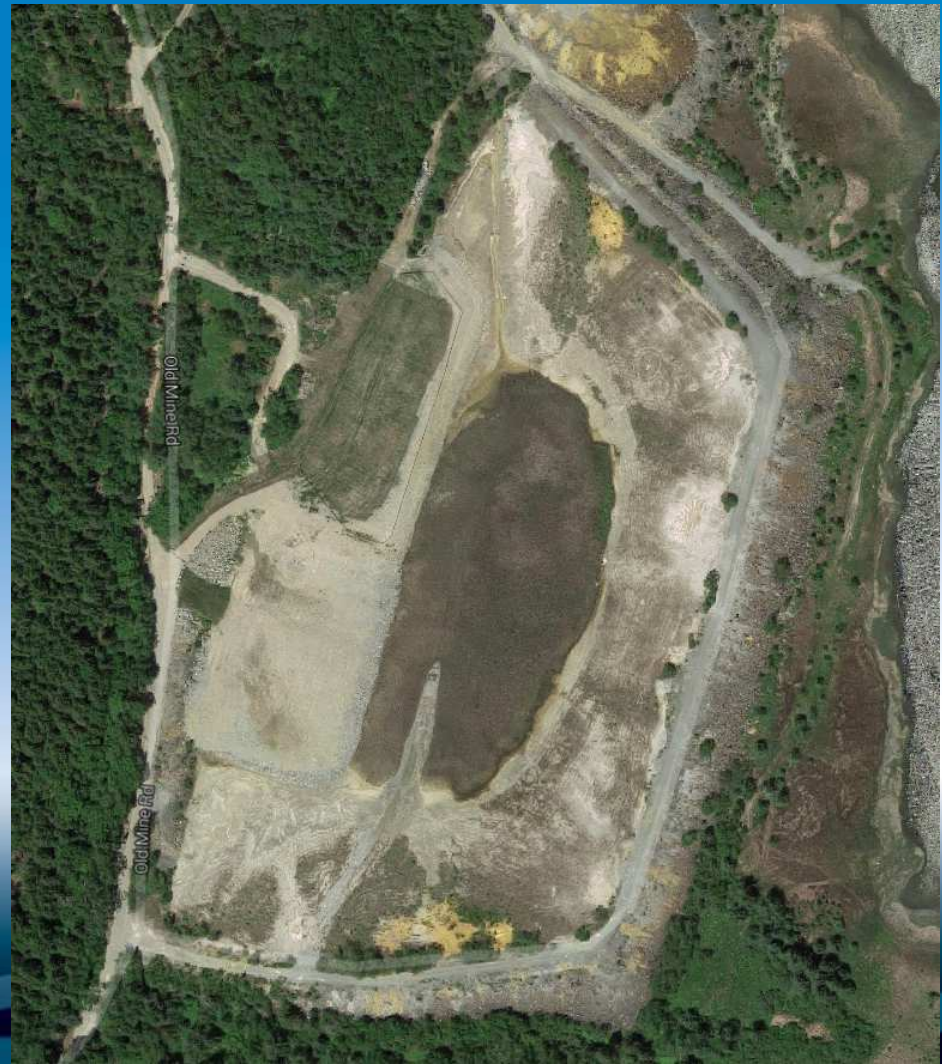
OU 3 Tailing Impoundment

- **17 acres**
- **Over 700,000 cubic yards of material**
 - Fine sand, silt and clay
 - Saturated material
- **Three sided dam**
 - 60' height
 - 1.3H to 1V
 - Constructed of cobble and boulder sized waste rock material

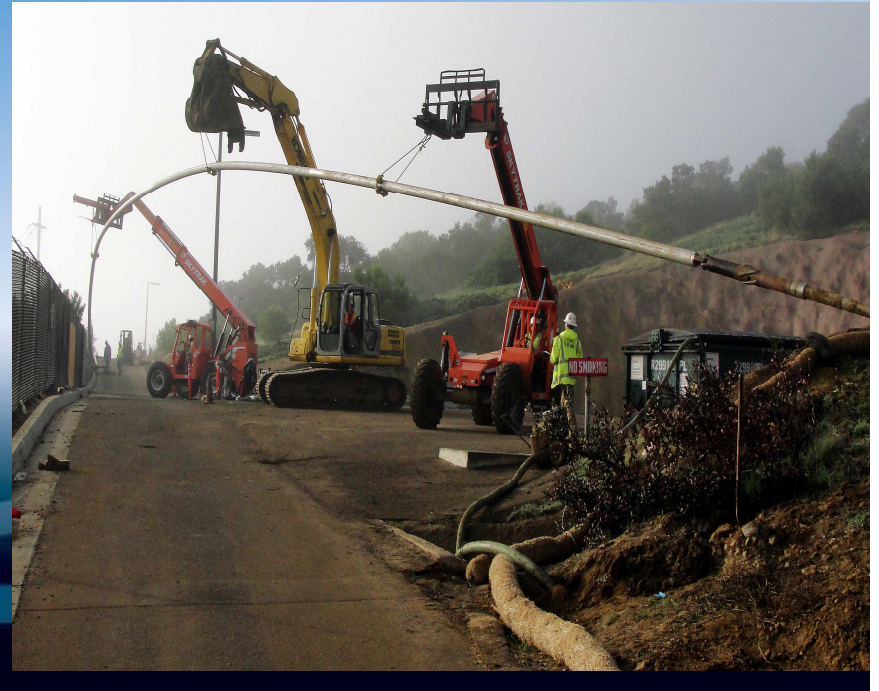
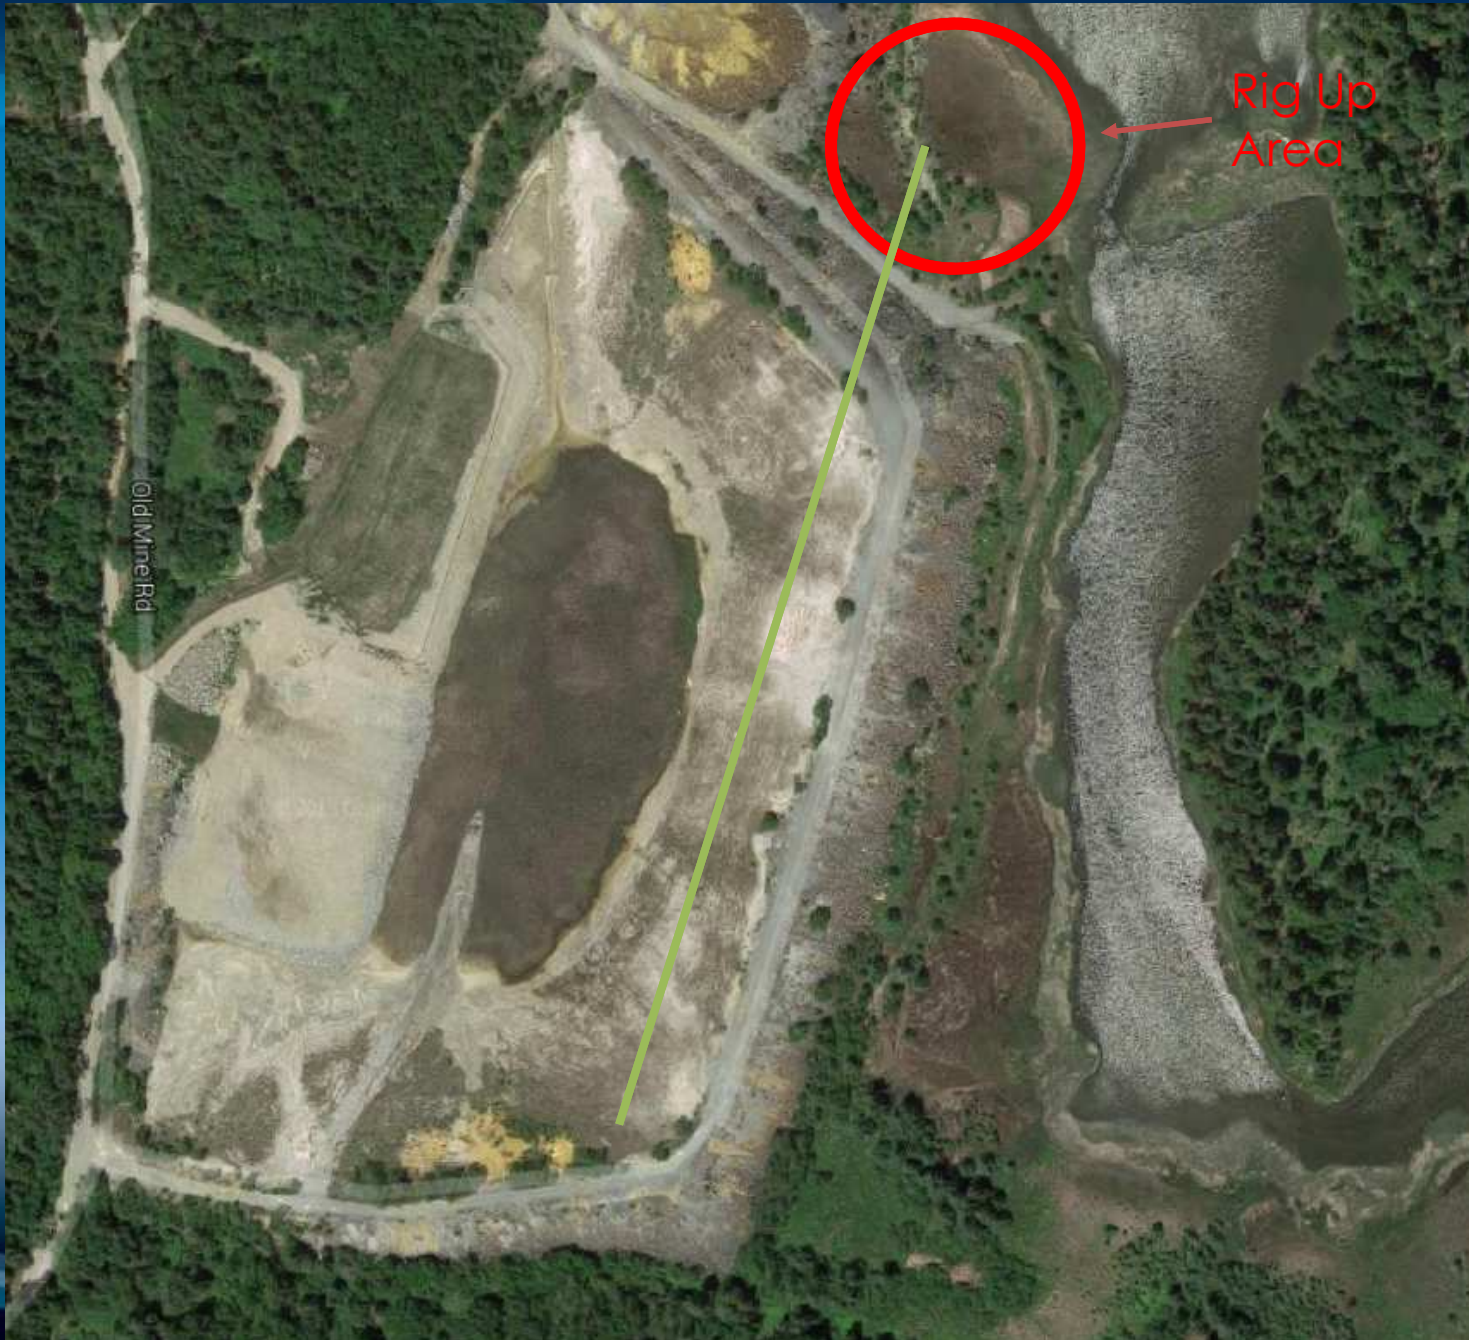
Rig Up Area

Site Constraints - Continuous

- Well screen needed to be at the base of the tailings
- No rig up area to drill from East to West
- Limited rig up area to the North
- No room to work or lay out well materials on the South side of the pond

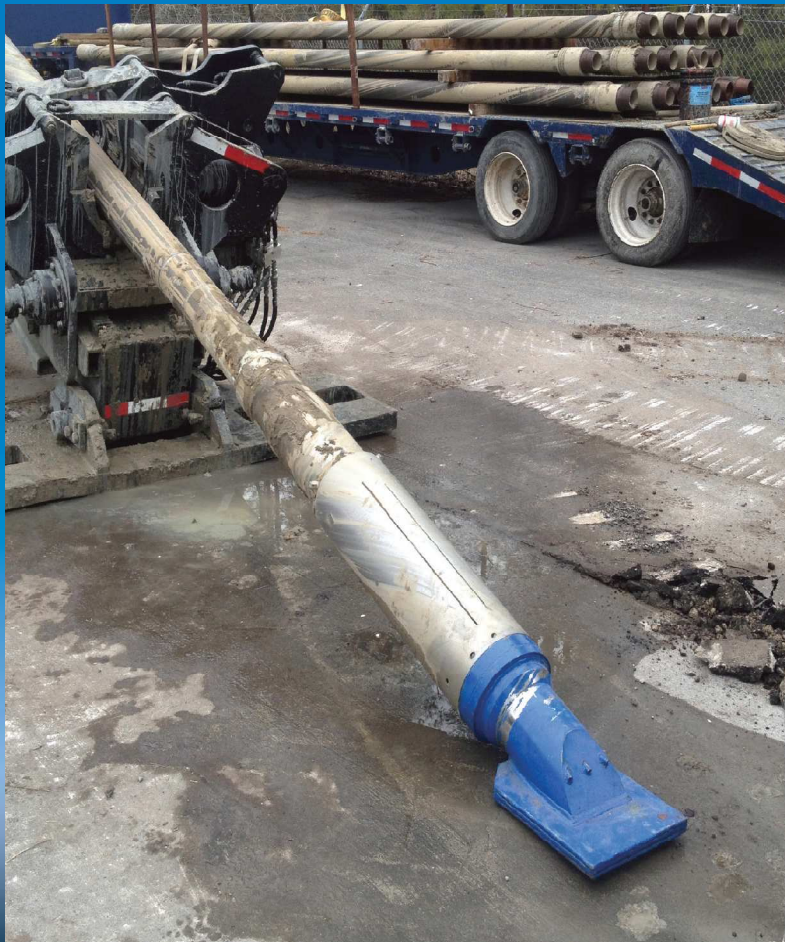
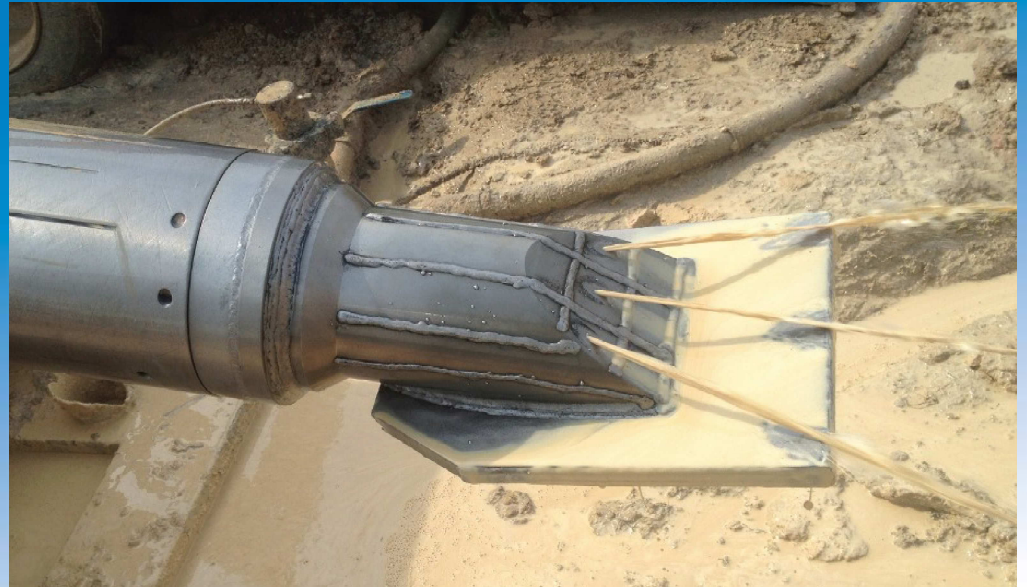
Knock Off Blind Well Method

Knock Off Installation

- The method would solve the problems of borehole stability and compressive forces on the PVC screen and casing
- **EVERYONE** still concerned about uncontrolled flow of tailings back to the rig

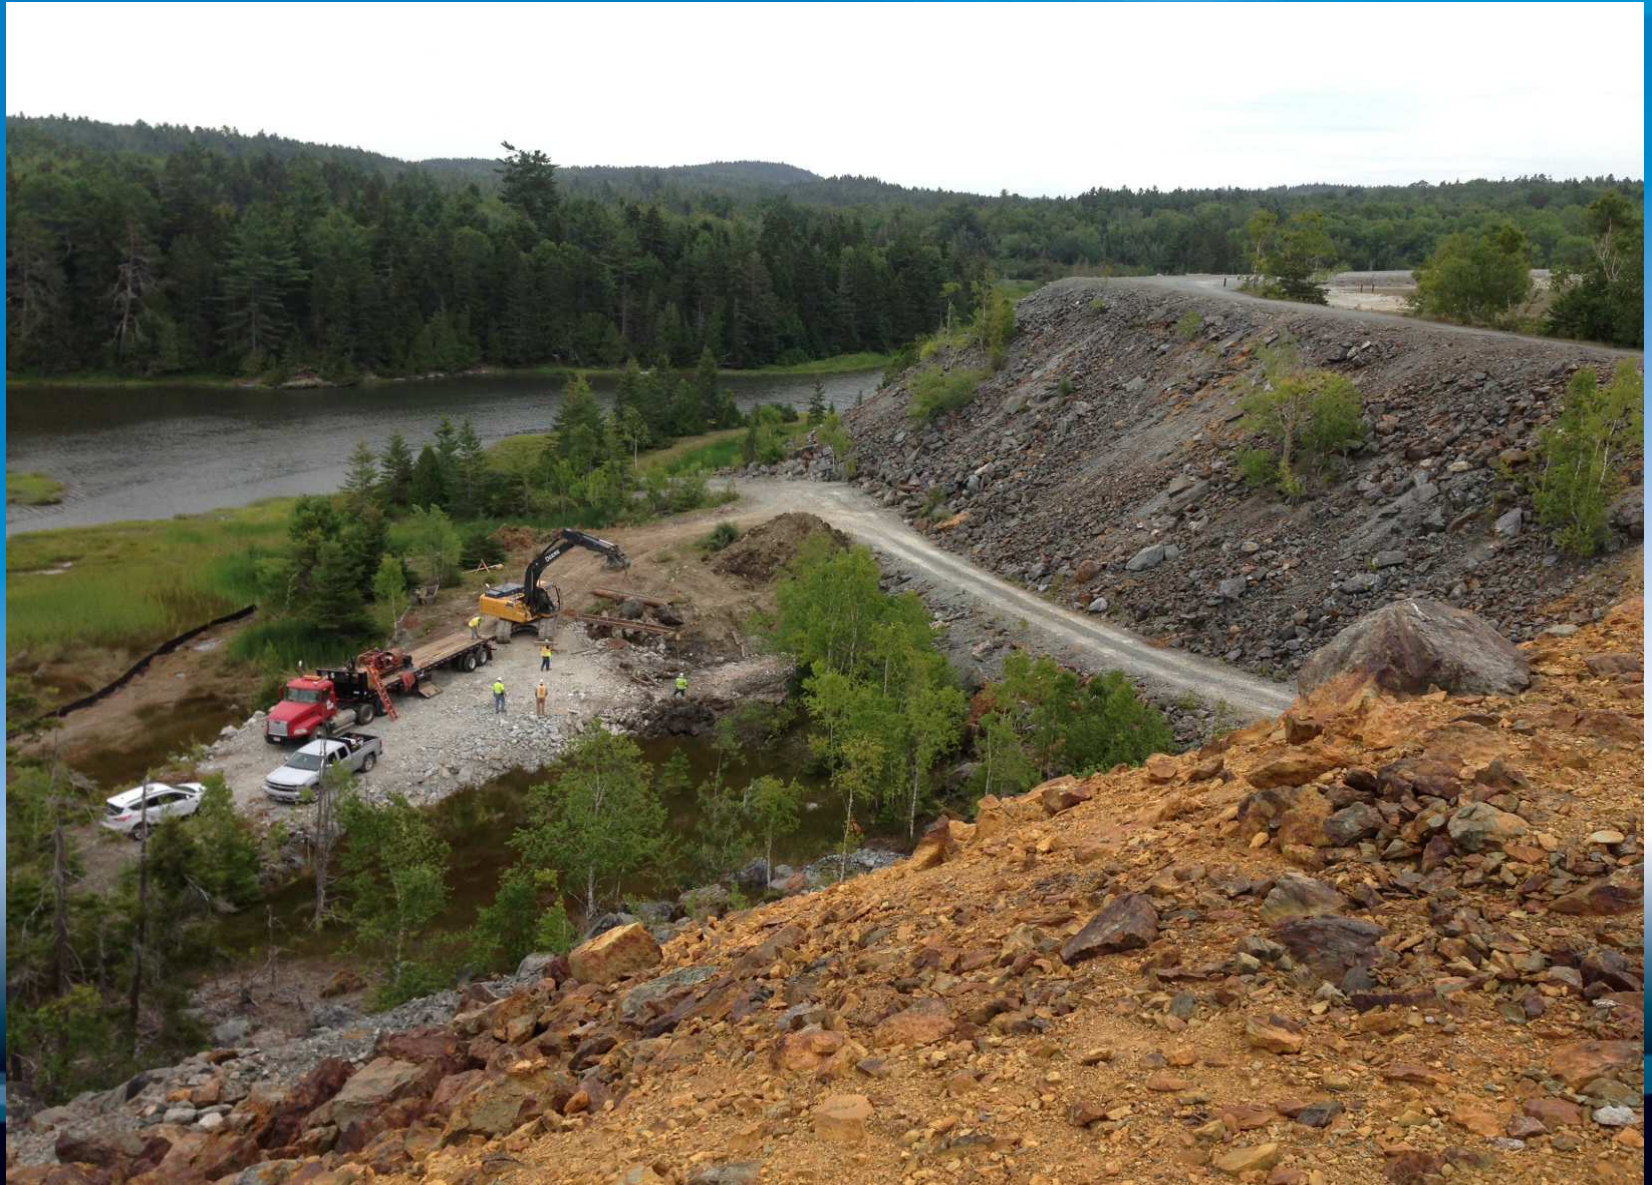
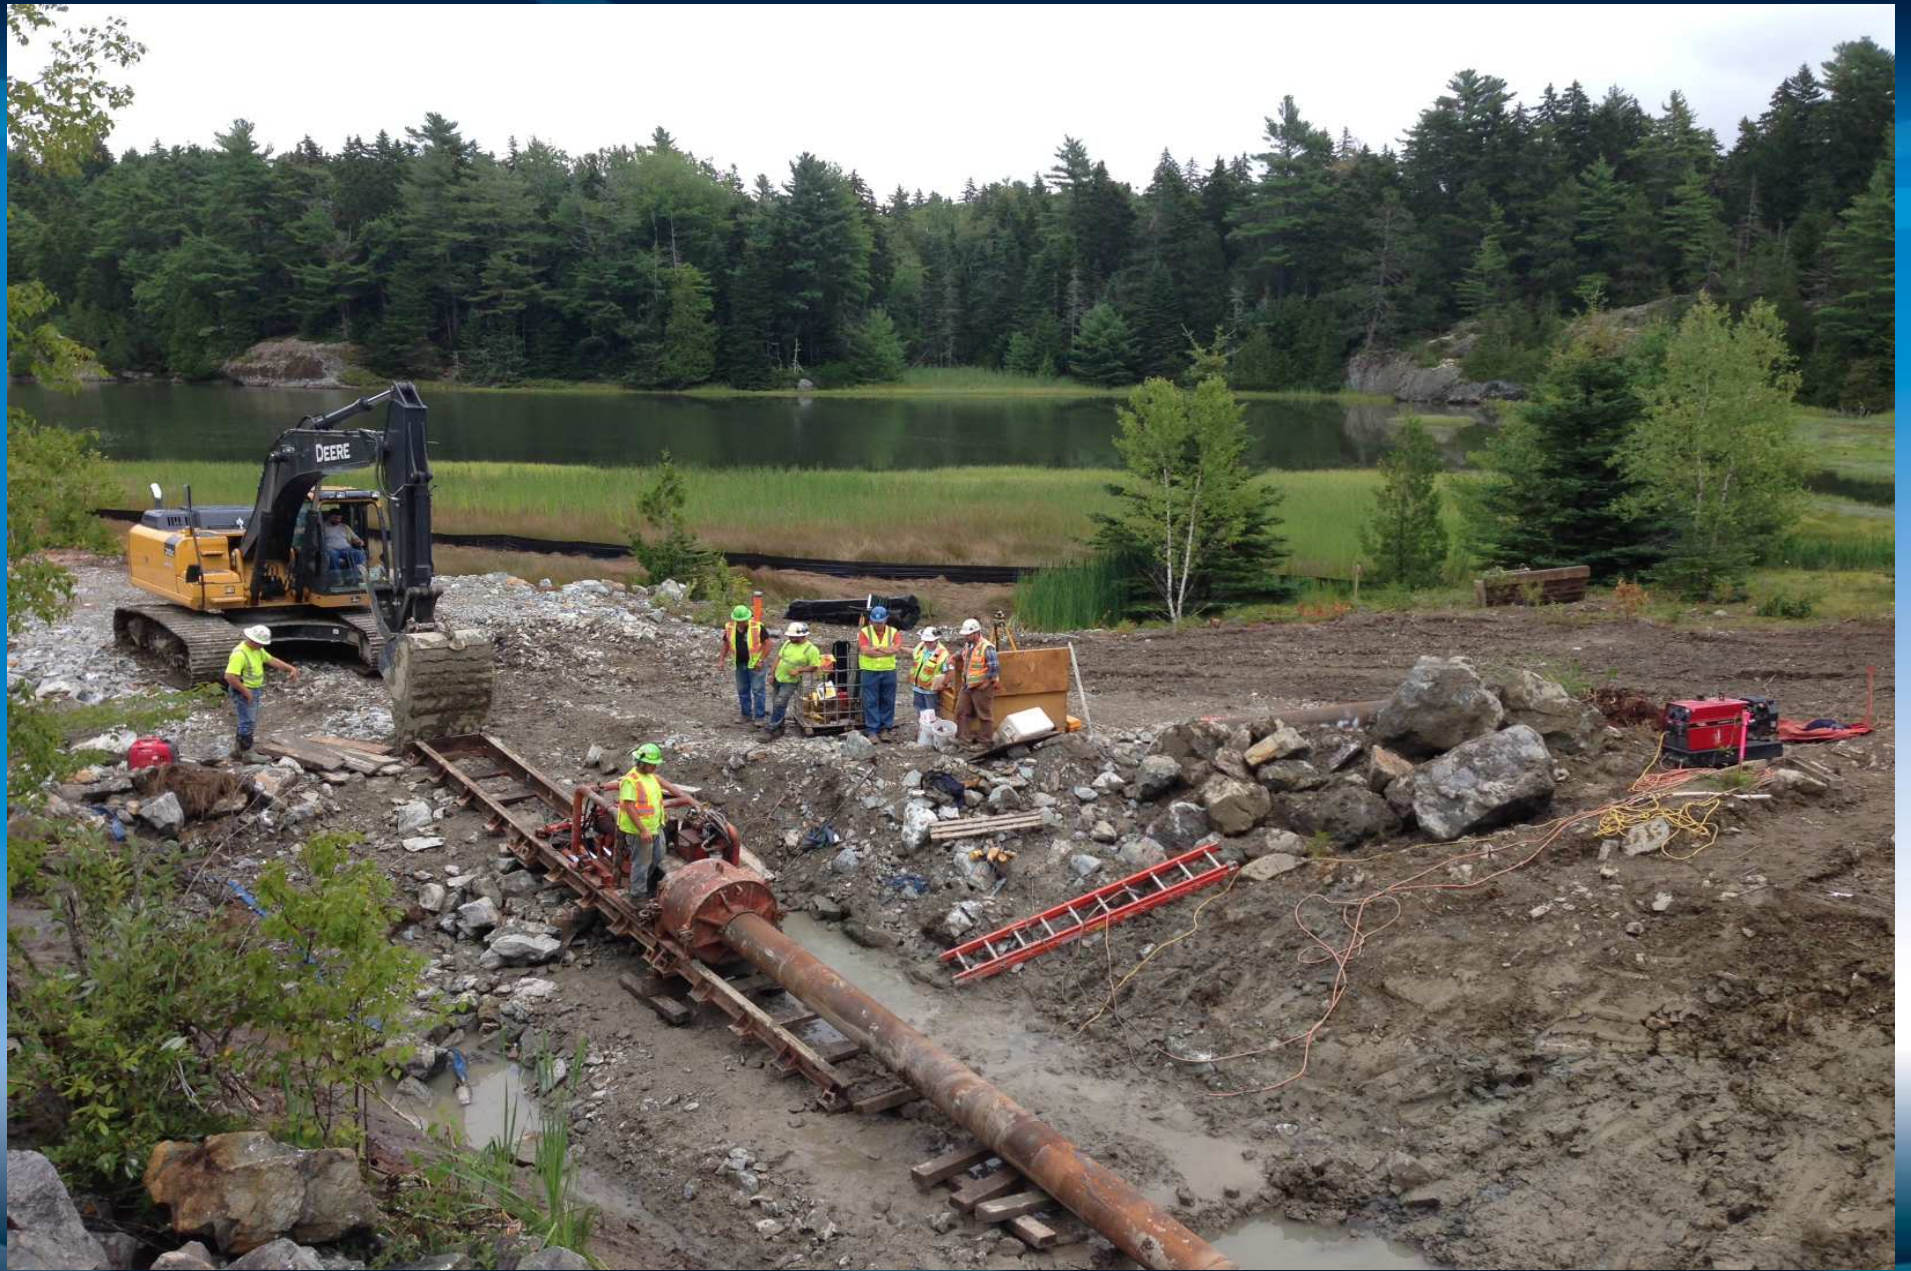
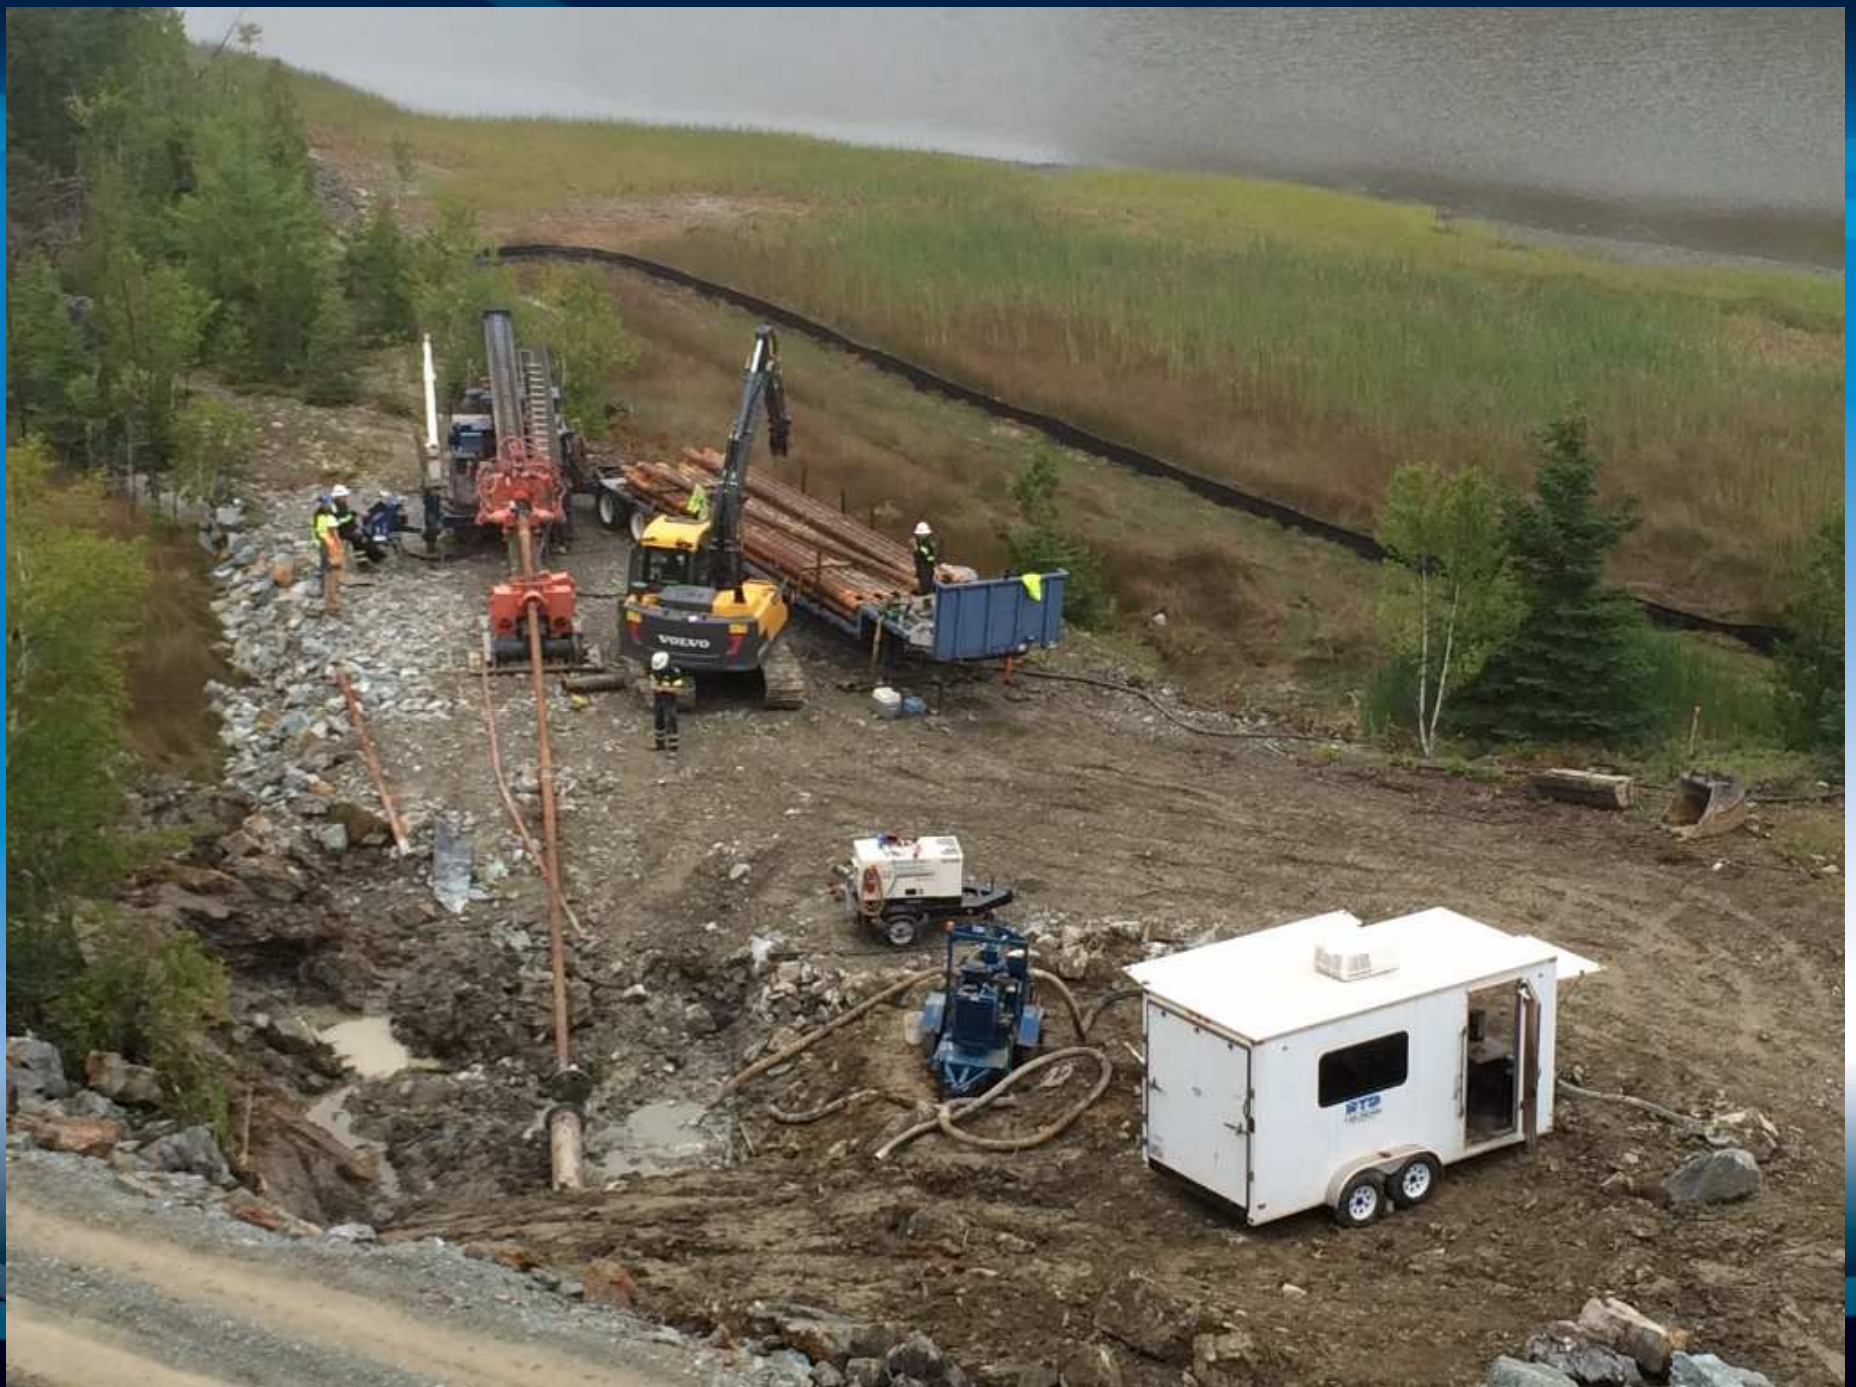
Drill Pad Construction

- Drill pad construction prior to equipment mobilization
- Install and cement 40' of 16" steel casing at the exit point
 - Crude horizontal “blow out” preventer
- Installed using auger boring methods
- Surface casing installation proved challenging
- Screen installed as a slope of 6° above horizontal
