# Final Report

# SAND COULEE ACID MINE DRAINAGE SOURCE CONTROL

# Abandoned Mine Reclamation Project

Cascade County, Montana

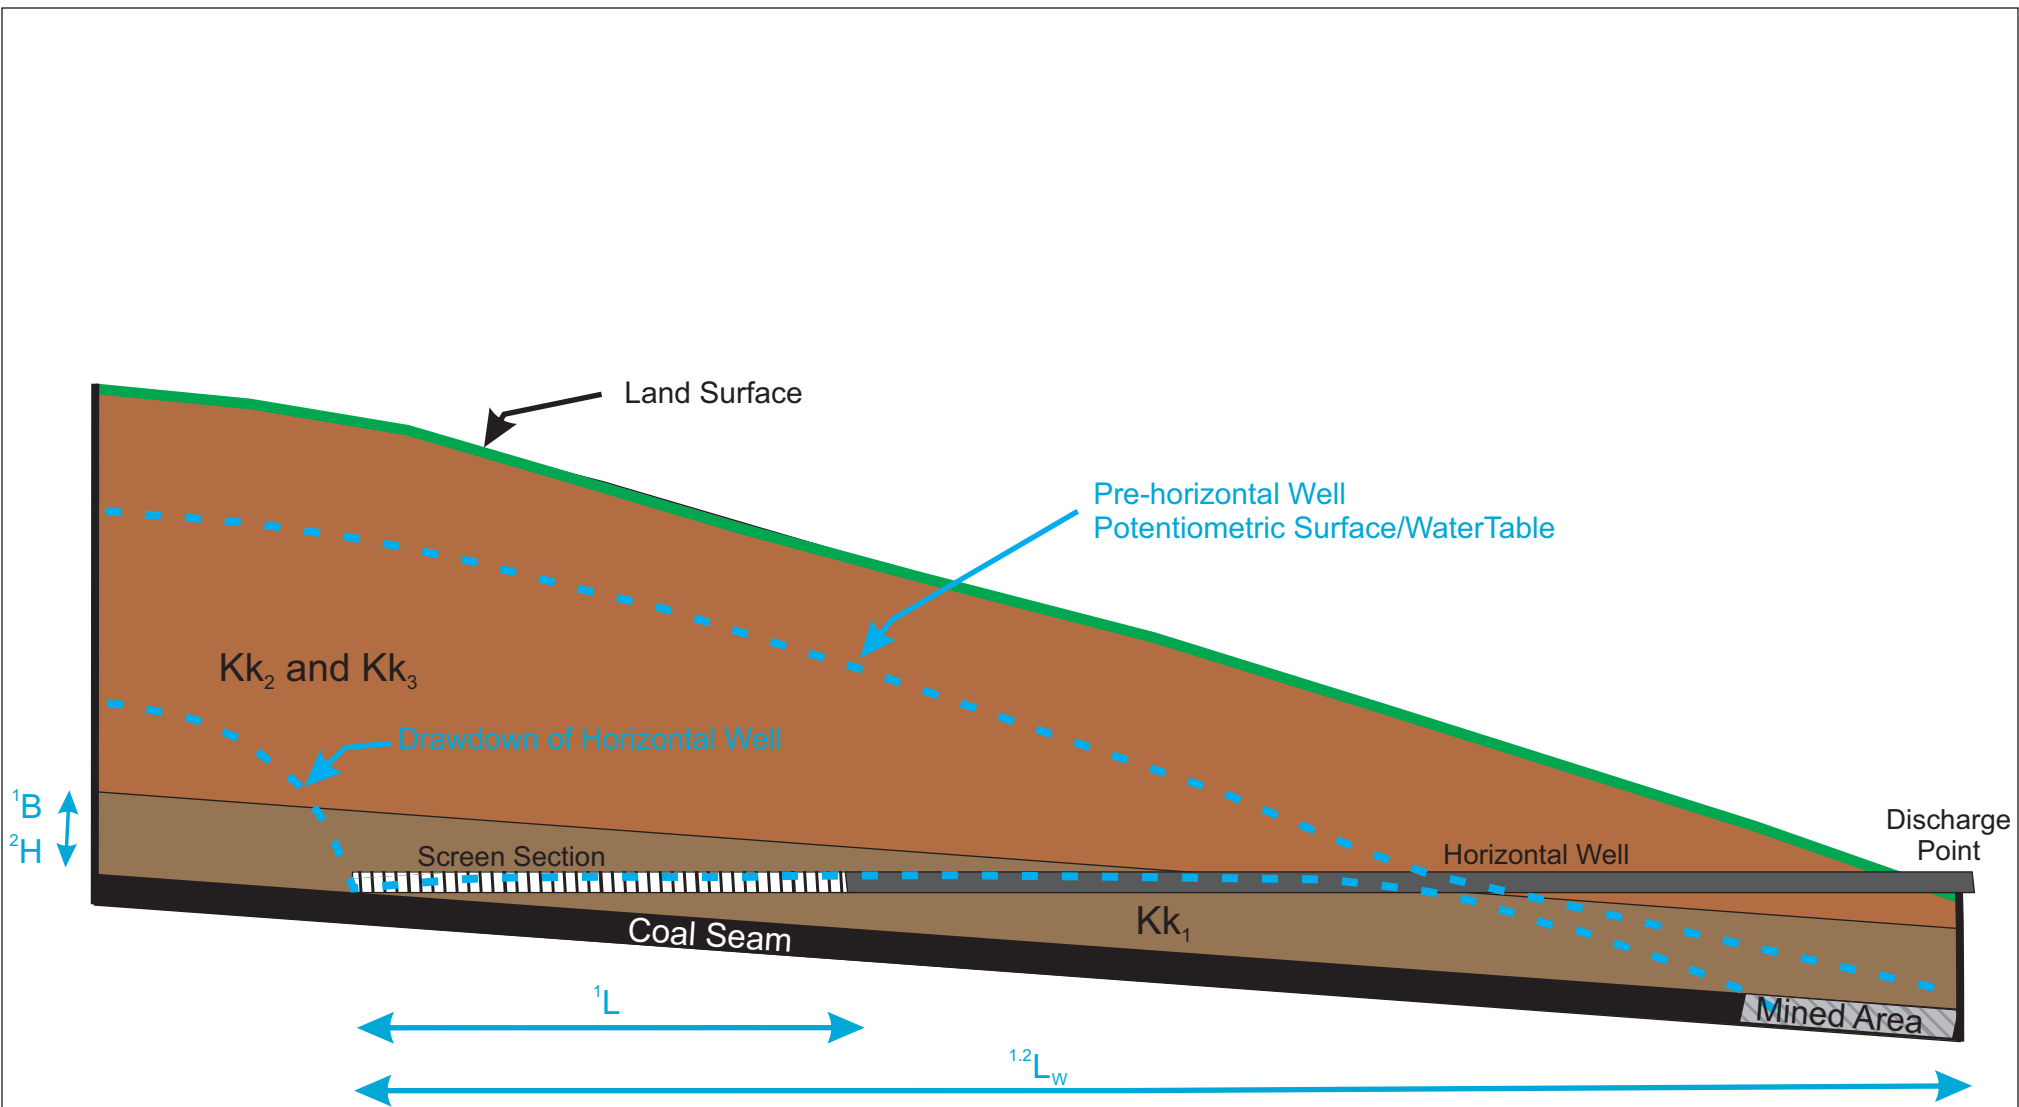
Figure 5. Conceptual Cross Section for Horizontal Well Design

Kk-Kootenai Formation Stratigraphic Units  
<sup>1</sup>HWELL Model Parameters  
<sup>2</sup>Dupuit-Forchheimer Model Parameters

The concept underlying this project is to intercept uncontaminated groundwater up-gradient of the historic mine workings using gravity-driven drainage wells in the Kk<sub>1</sub>, and thereby reduce the leakage into and AMD emanating from the old mine workings. Two well designs were considered, a horizontal or low angle well, and a vertical drainage well. A horizontal well design may include some angle above or below the horizontal, but it is much closer to horizontal than vertical in orientation, and would have to be installed using directional drilling technology. The vertical drainage well would be installed by a conventional water well contractor. The conceptual horizontal well is depicted in Figure 5 and the conceptual vertical drainage well depicted in Figure 6.

Horizontal wells offer an effective alternative to vertical wells, due to the greater screen length and aquifer contact. In certain favorable site conditions, horizontal wells can be used to discharge groundwater to the surface using gravity-driven drainage. The horizontal well would be spudded at the lowest feasible elevation in Sand Coulee up-gradient (southwest) of the Gerber mine boundary. For the purpose of the current evaluation, the maximum practical horizontal well length was determined to be 1,500 to 2,000 feet in length and 4 to 6 inches in diameter based on cost considerations and a review of available literature on horizontal well completions (HydroSolutions Inc 2014). The screened interval would be within the confined Kk<sub>1</sub> and extend approximately 500 feet. The well would be completed with solid pipe from the screen to the well head in the coulee bottom, where drainage water could be discharged or shut-in with a valve.

The potentiometric head of the Kk<sub>1</sub> aquifer at the well screen must be sufficiently greater than the well head elevation to produce a target flow rate while overcoming friction losses within the well. The initial groundwater interception investigation (HydroSolutions 2014) found that, using two different modeling approaches and including friction loss, a 50-foot potentiometric head difference would result in an estimated flow rate of from 86 to 138 gpm for a 4-inch diameter well, and from 104 to 225 gpm for a 6-inch diameter well. Sensitivity analysis showed that varying the model parameters to conservative estimates could result in a flow rate as small as 11 gpm.

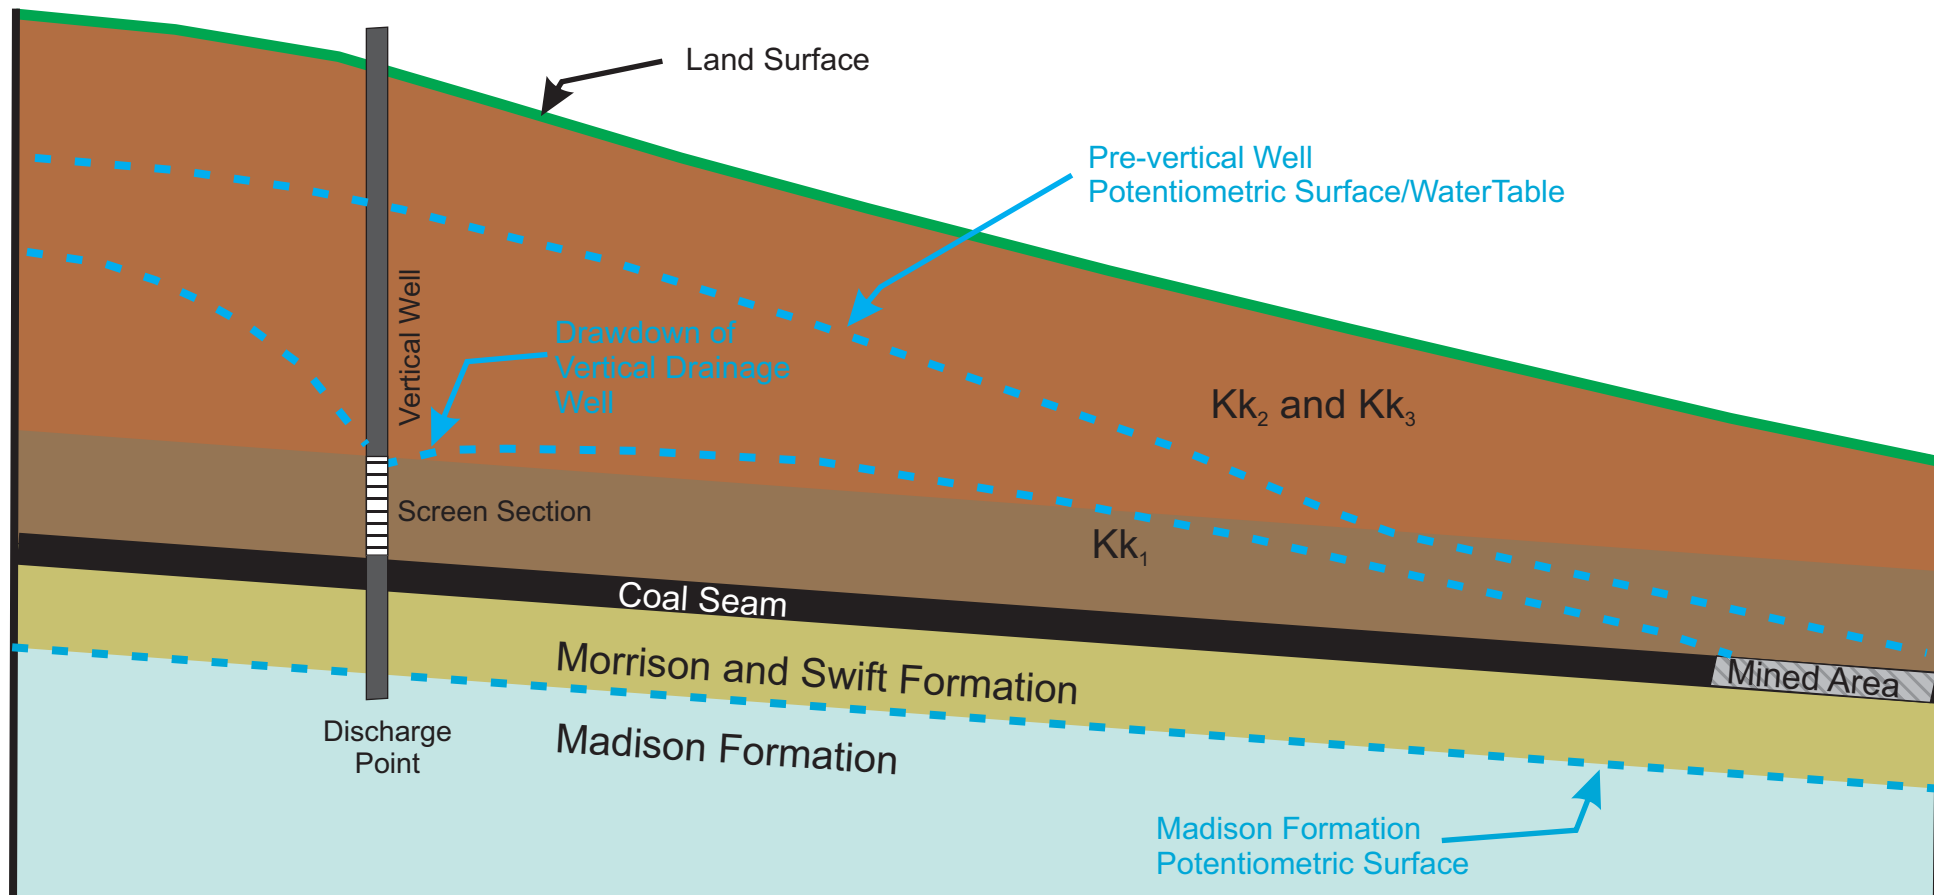
Figure 5. Conceptual Cross Section for Vertical Well Design

Kk-Kootenai Formation Stratigraphic Units

Similar to the horizontal well application, the objective for the vertical interception well is a reduction in the volume of groundwater available for leakage into the historic mine workings. Gravity-driven vertical drainage wells provide additional installation opportunities when compared with gravity-driven horizontal wells at the locations evaluated because they are not as dependent upon spud elevations. Compared with the horizontal wells, a vertical drainage well is not dependent on elevations providing natural drainage at the spud location. Gravity-driven horizontal drainage wells require sufficient elevation change to allow for head in the selected aquifer to drain without pumping.

A vertical drainage well connecting the Kk<sub>1</sub> aquifer directly to the Madison aquifer would be less expensive than a horizontal well. Given the surface elevations found within the drainages and the head encountered in Kk<sub>1</sub>, more opportunities to locate pilot vertical interception wells exist up-gradient of all mines. Recommended locations include within Sand Coulee near MW-102K, the vicinity of MW-103K which is just up-gradient of the Gerber Mine workings, and possibly on the bench above Sand Coulee near MW-101K after additional geologic interpretation and modeling to evaluate the specific location is completed.

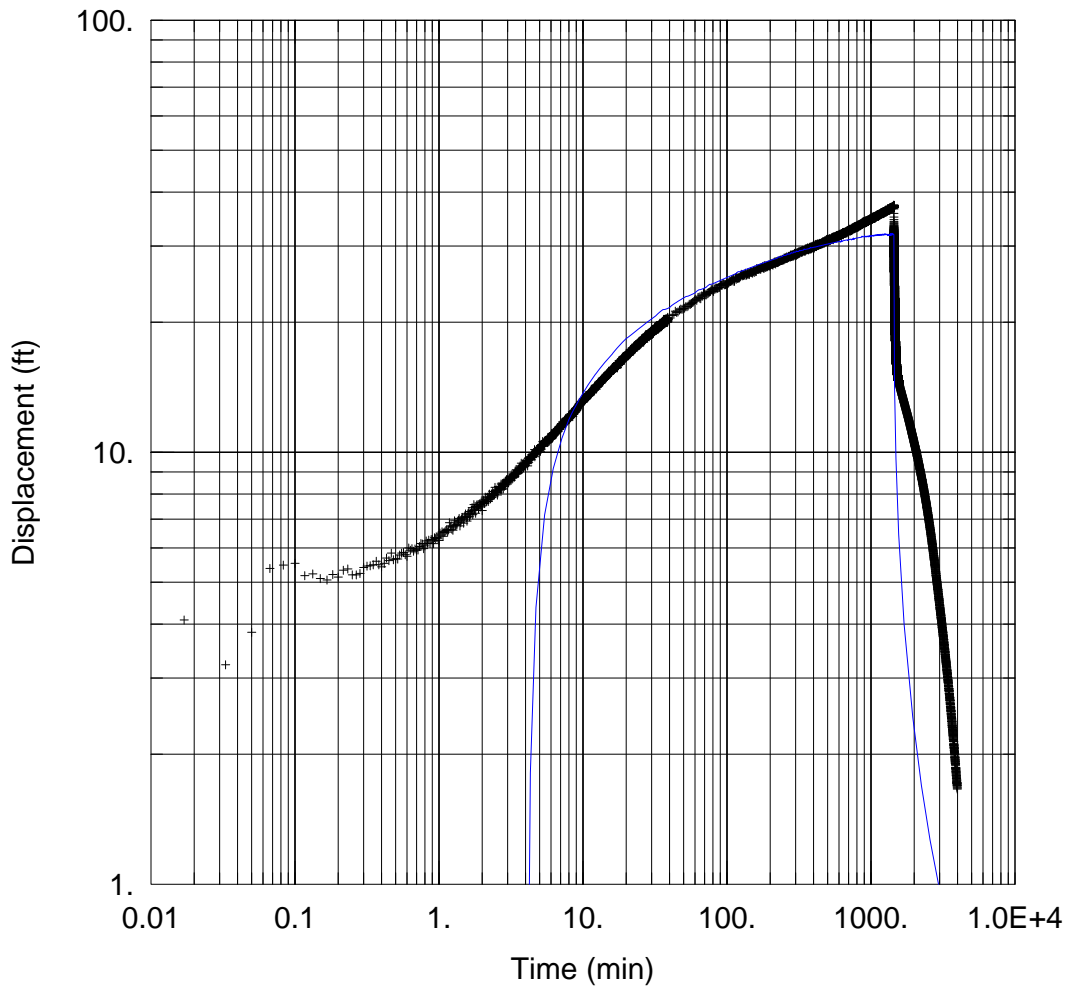
Data Set: H:\...\MW102K\_24hrconfTheis.aqt

Kz/Kr = 1.

b = 75. ft

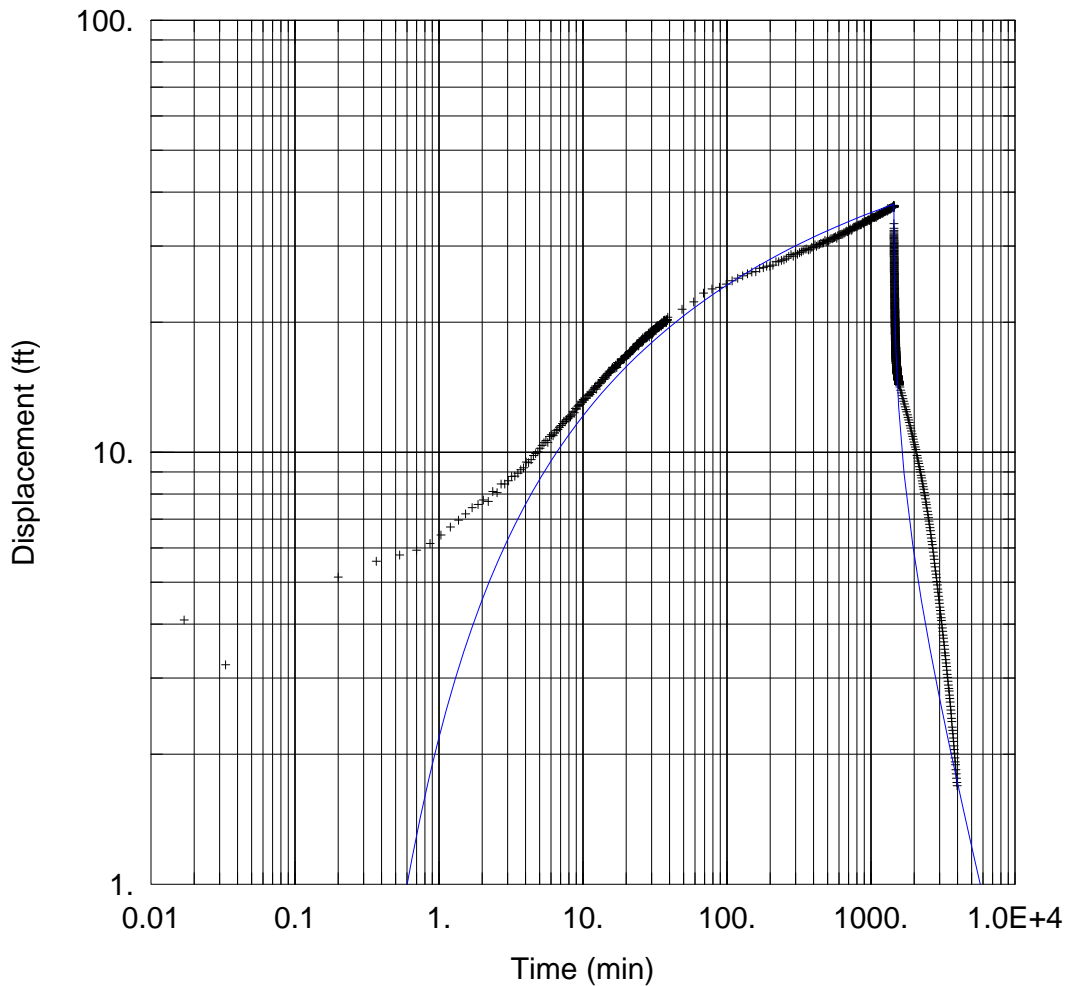
Data Set: H:\...\MW102K\_24hrHantush\_Jacob\_Leaky.aqt  
 Date: 02/01/18 Time: 10:54:52

Aquifer Model: <u>Leaky</u> $T = 381.5 \text{ ft}^2/\text{day}$ $1/B = 3.03E-5 \text{ ft}^{-1}$ $b = 75. \text{ ft}$	Solution Method: <u>Hantush-Jacob</u> $S = 6.554$ $Kz/Kr = 1.$
---	--

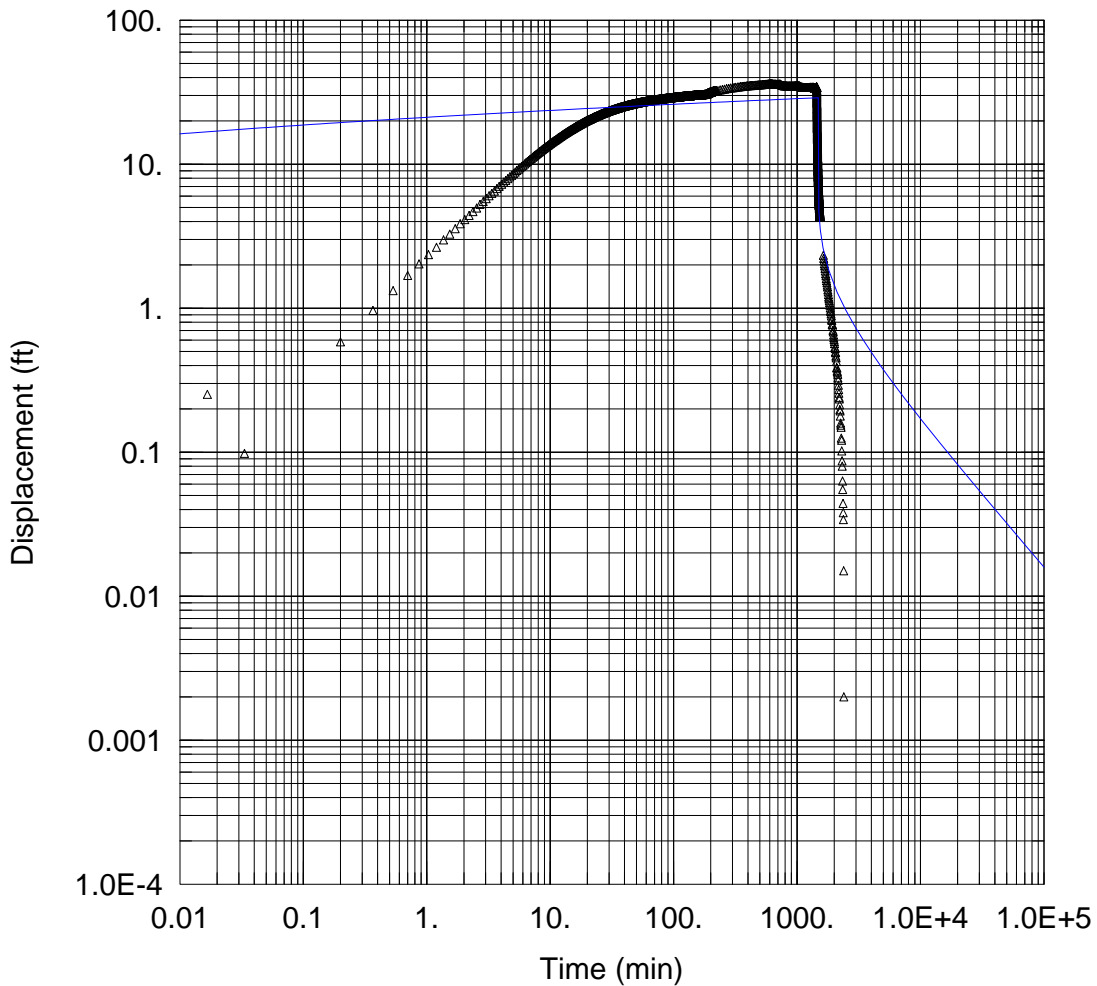
Data Set: H:\...\MW103K\_24hr\_final\_TheisConf.aqt

Kz/Kr = 0.1949

b = 52. ft

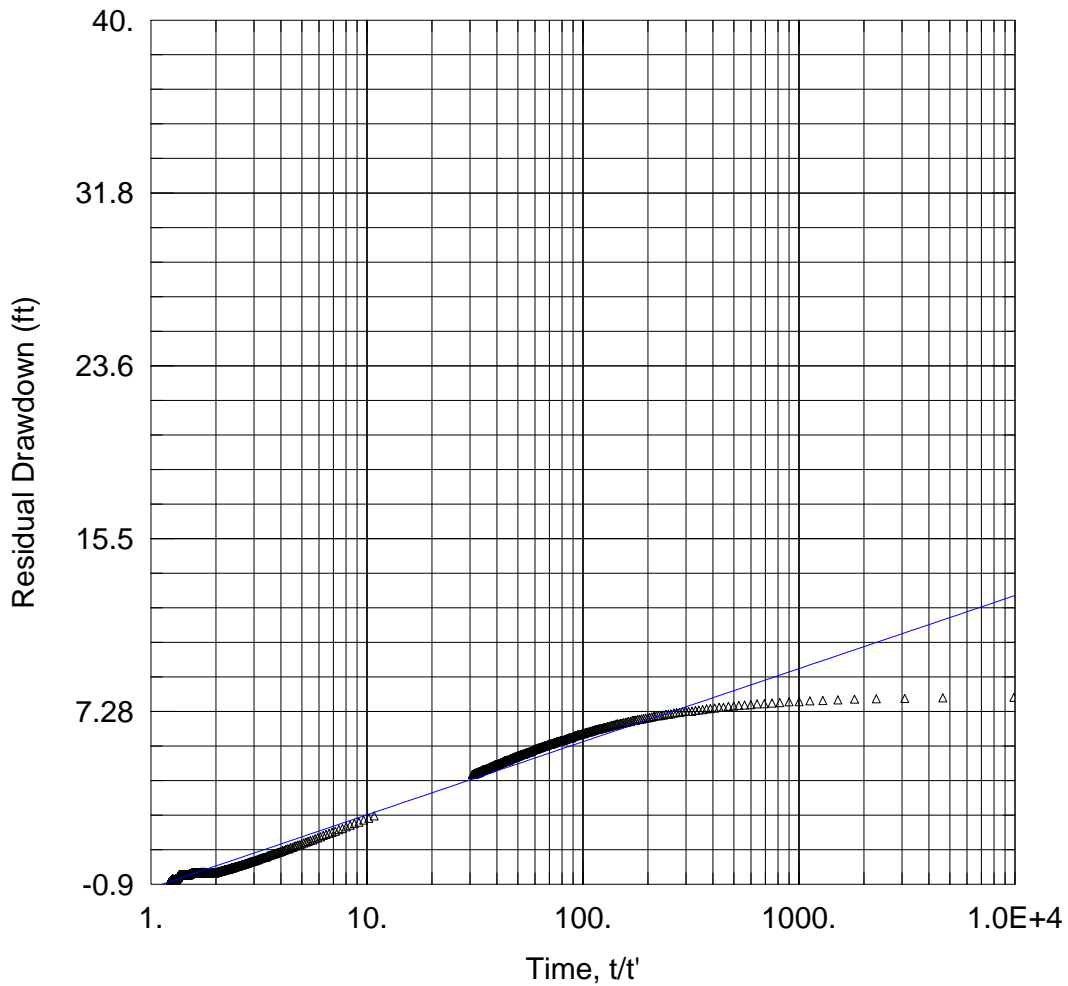
Data Set: H:\...\MW103K\_24hr\_final\_TheisConf\_recov.aqt  
 Date: 02/01/18 Time: 11:04:17

Aquifer Model: Confined Solution Method: Theis (Recovery)  
 $T = 27.53 \text{ ft}^2/\text{day}$   $S/S' = 2.047$

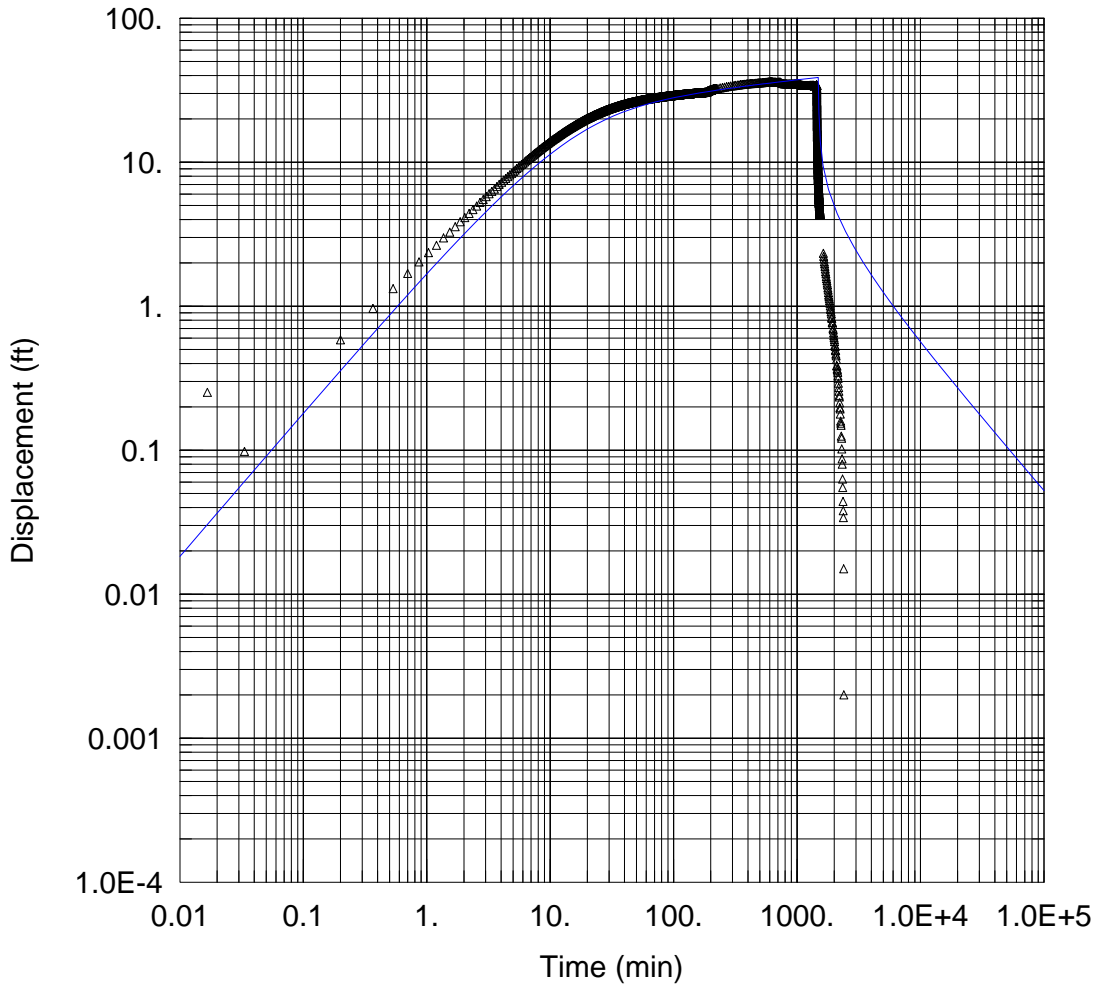
Data Set: H:\...\MW103K\_24hr\_final\_TheisConf\_papadopoulos\_cooper.aqt  
 Date: 02/01/18 Time: 11:03:07

Aquifer Model: Confined Solution Method: Papadopoulos-Cooper  
 $T = 11.79 \text{ ft}^2/\text{day}$   $S = 0.002406$   
 $r(w) = 0.42 \text{ ft}$   $r(c) = 0.25 \text{ ft}$

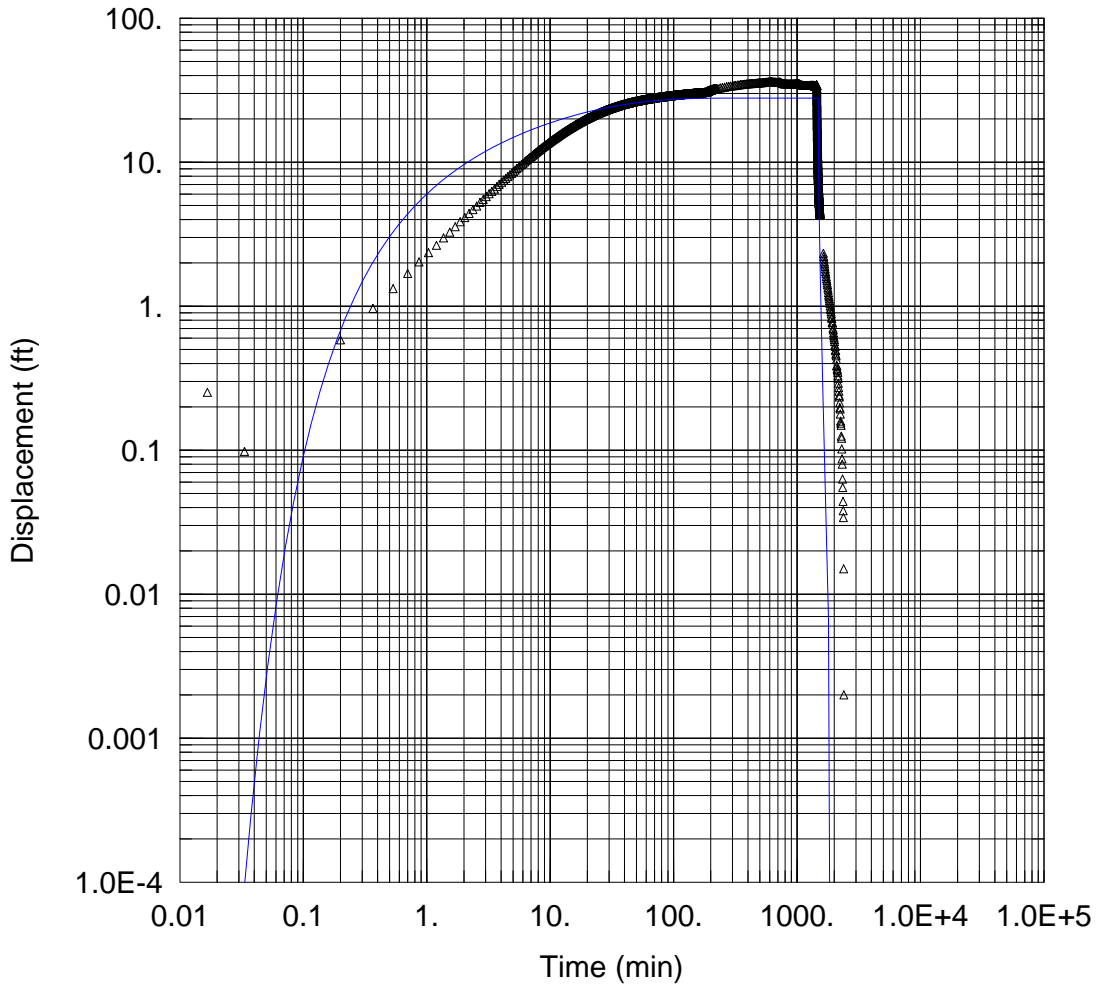
Data Set: H:\...\MW103K\_24hr\_final\_Hantush\_Jacob\_Leaky.aqt  
 Date: 02/01/18 Time: 10:58:29

Aquifer Model: <u>Leaky</u>	Solution Method: <u>Hantush-Jacob</u>
T = <u>6.253 ft<sup>2</sup>/day</u>	S = <u>0.0291</u>
1/B = <u>0.3301 ft<sup>-1</sup></u>	Kz/Kr = <u>0.1949</u>
b = <u>52. ft</u>
